AN ARMKO INDUSTRIES, INC. ROOF SURVEY
FOR
3100 MAIN ADMINISTRATION BUILDING
FOR
HOUSTON COMMUNITY COLLEGE SYSTEM
HOUSTON, TX

SUBJECT: ROOF SURVEY FOR ADMINISTRATION BUILDING 3100 MAIN EYEBROWS

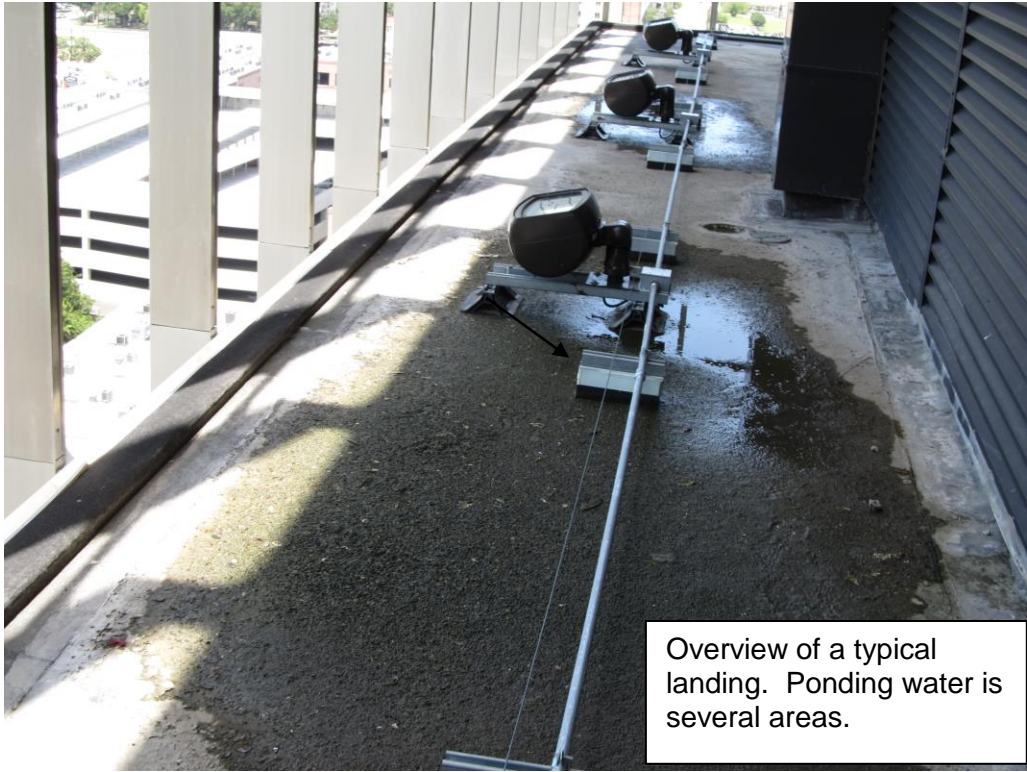
Overview of a typical landing. Ponding water is several areas.

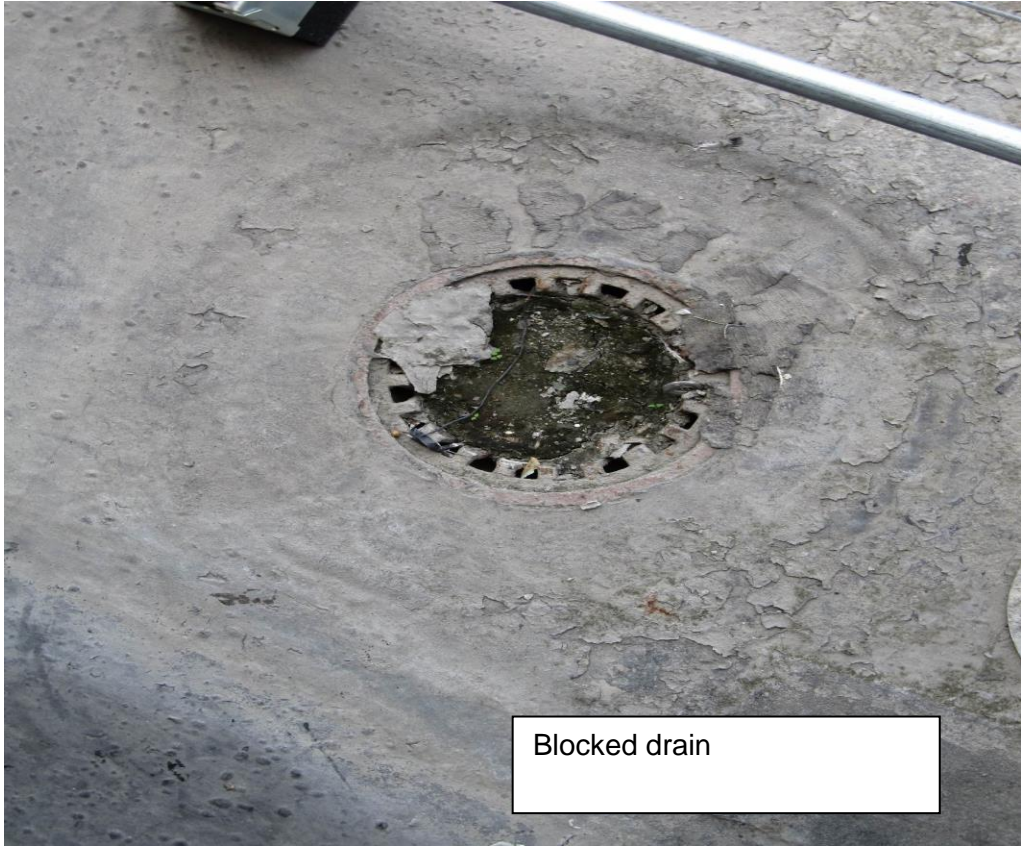
Blocked drain

- 1.02.5 Perimeters: The perimeter edge of the eyebrow roof is terminated in the granite fascia with sealant and a plastic insert. The insert is loose or missing in many places.
- 1.02.6 Field of Roof: In the area in which the core was taken the field of the roof is intact, however evidence of previous moisture was noted.
- 1.02.6 Drains: Surface drains are the primary drainage for the eyebrows, several of the drains are blocked with debris and appear to have been that way for some time. Recommendation is to clear the drains and verify they are functioning properly.

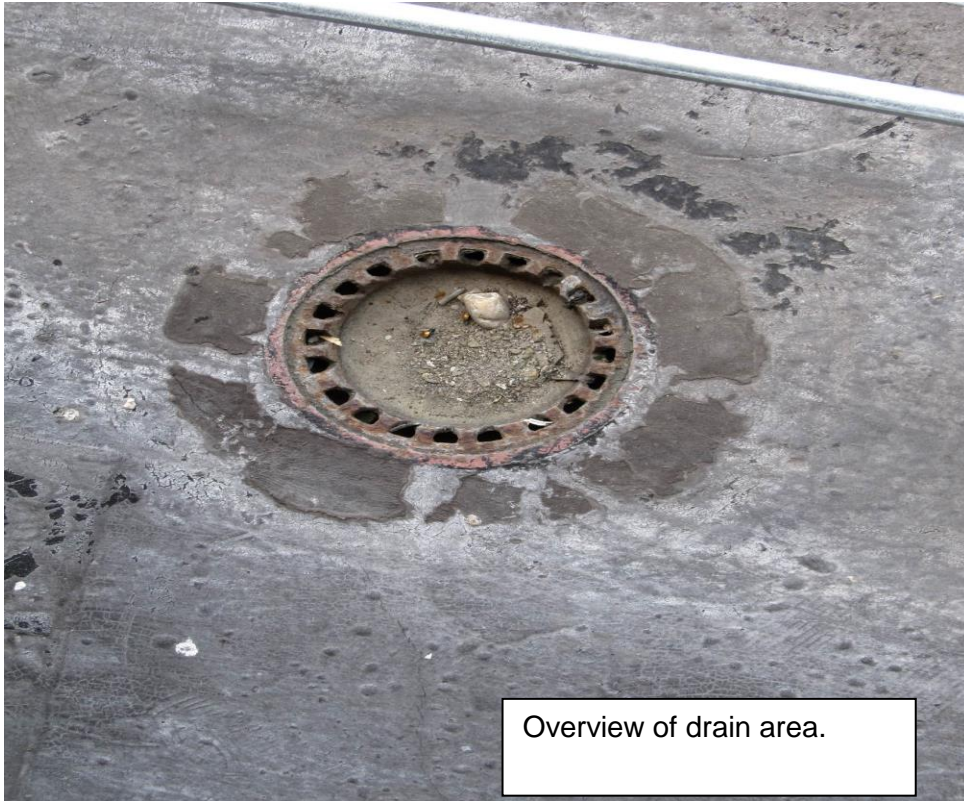
Overview of drain area.

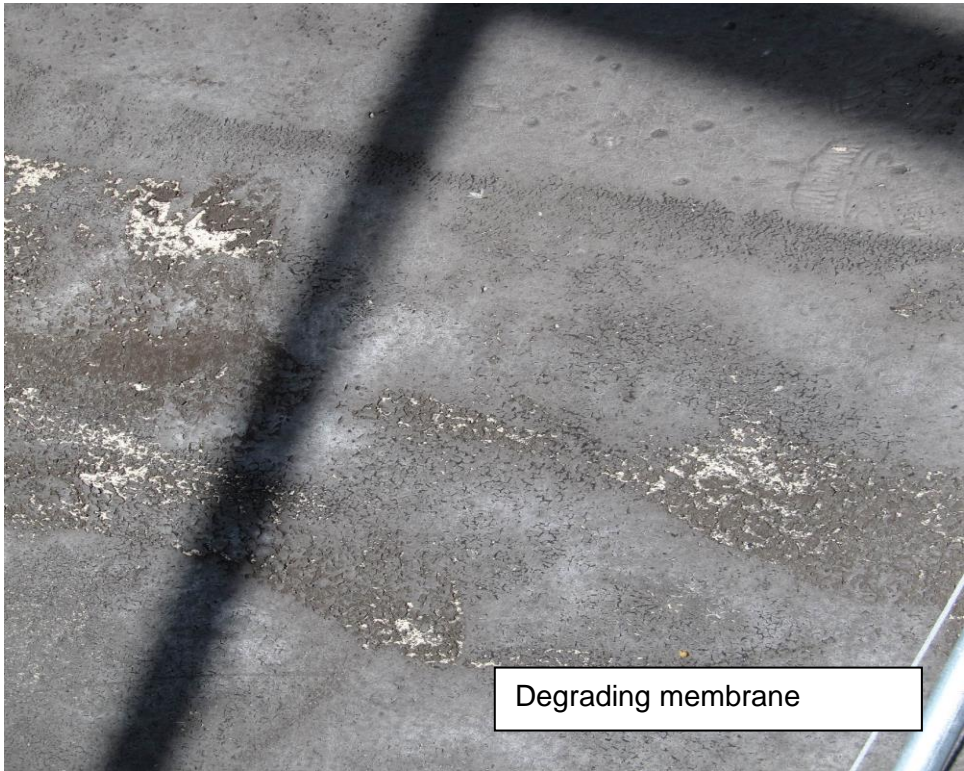
Degrading membrane

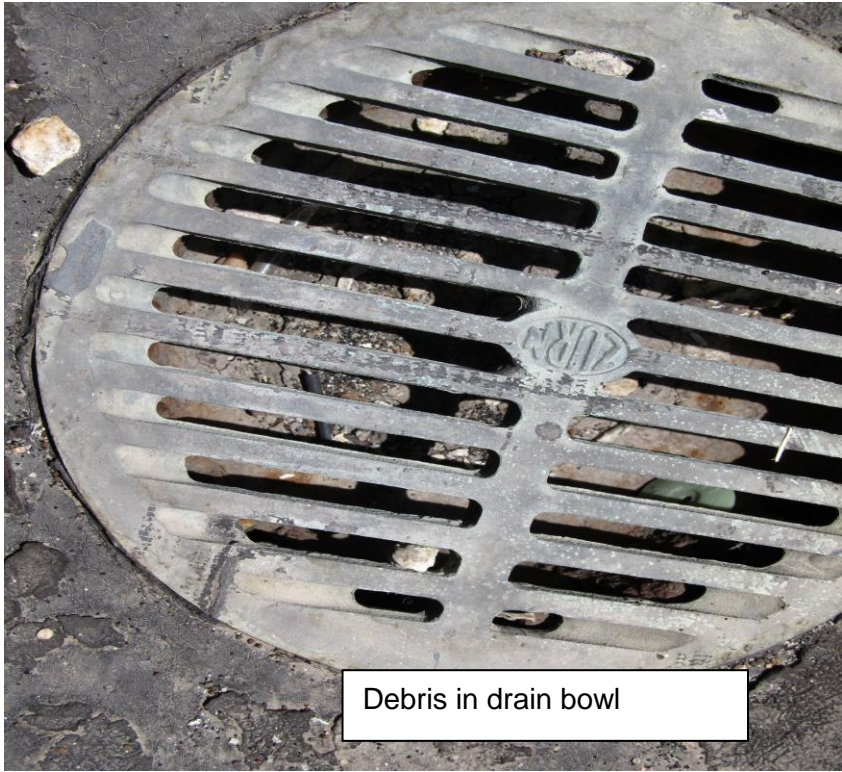
Debris in drain bowl

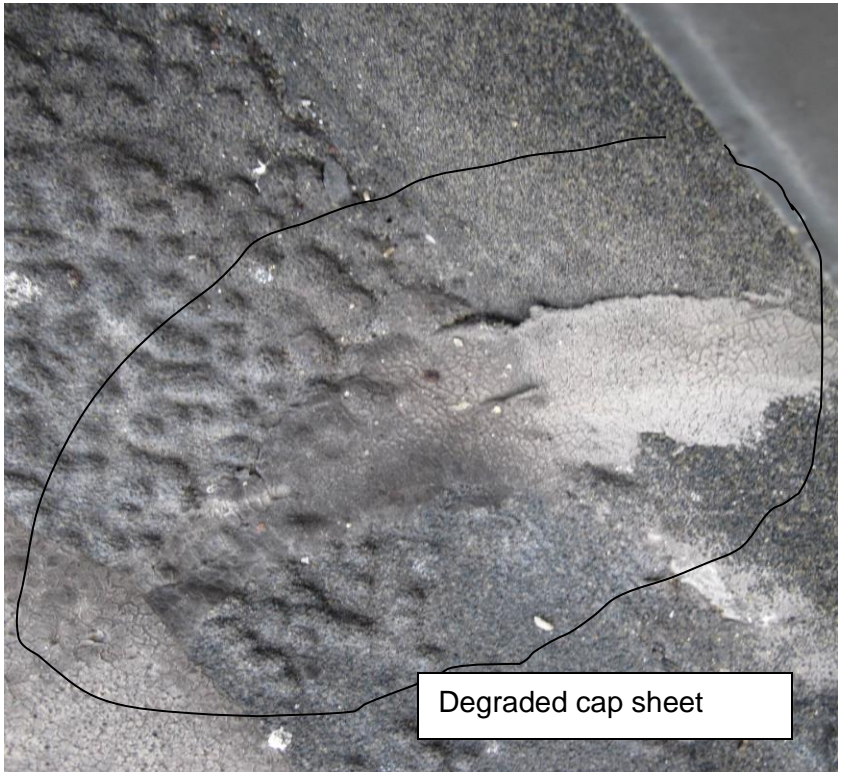
Degraded cap sheet

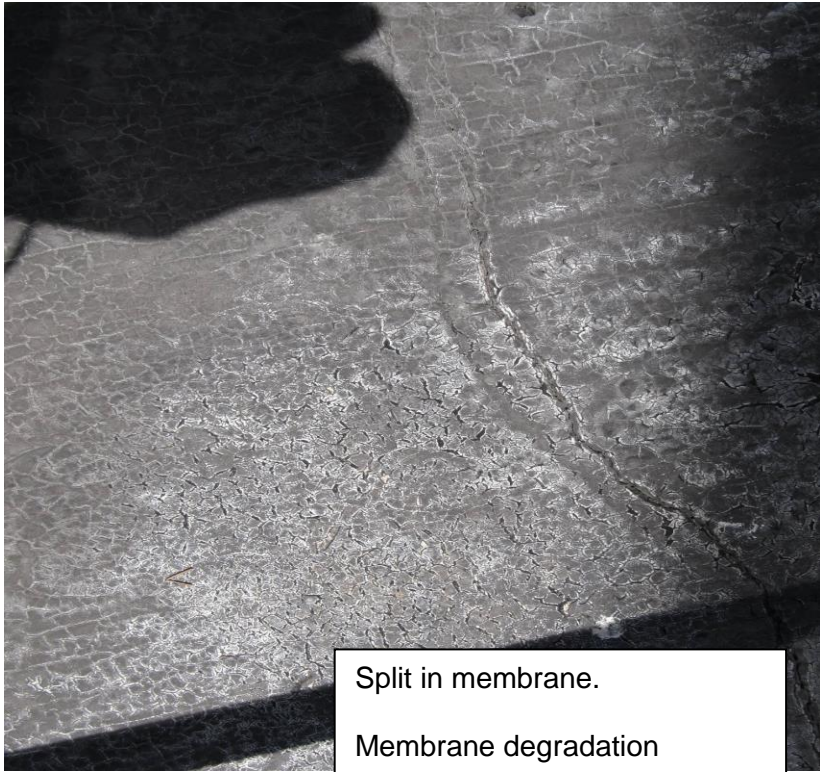
Split in membrane.
Membrane degradation

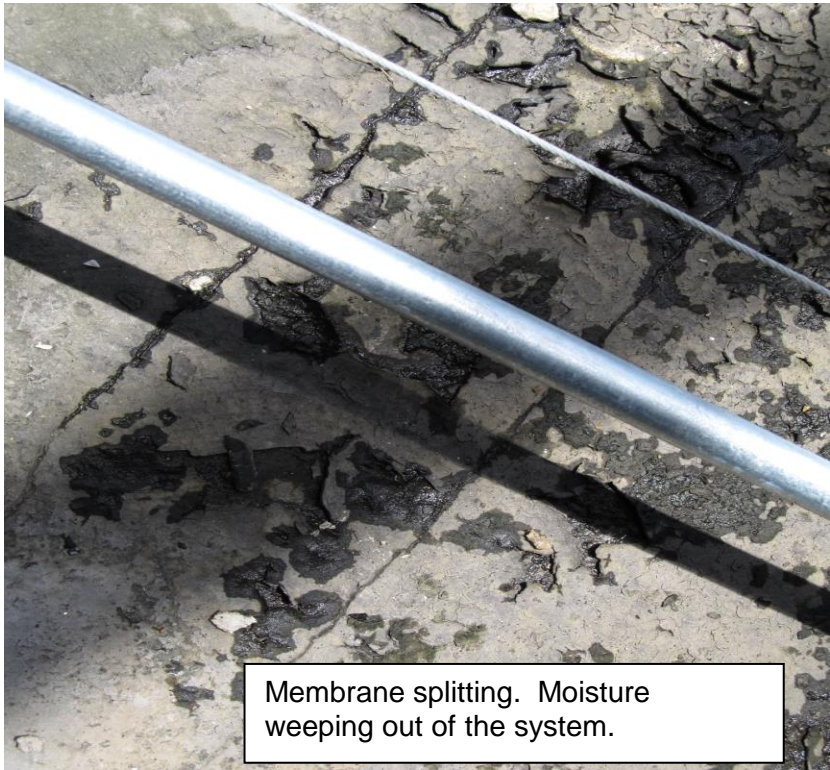
Membrane splitting. Moisture weeping out of the system.

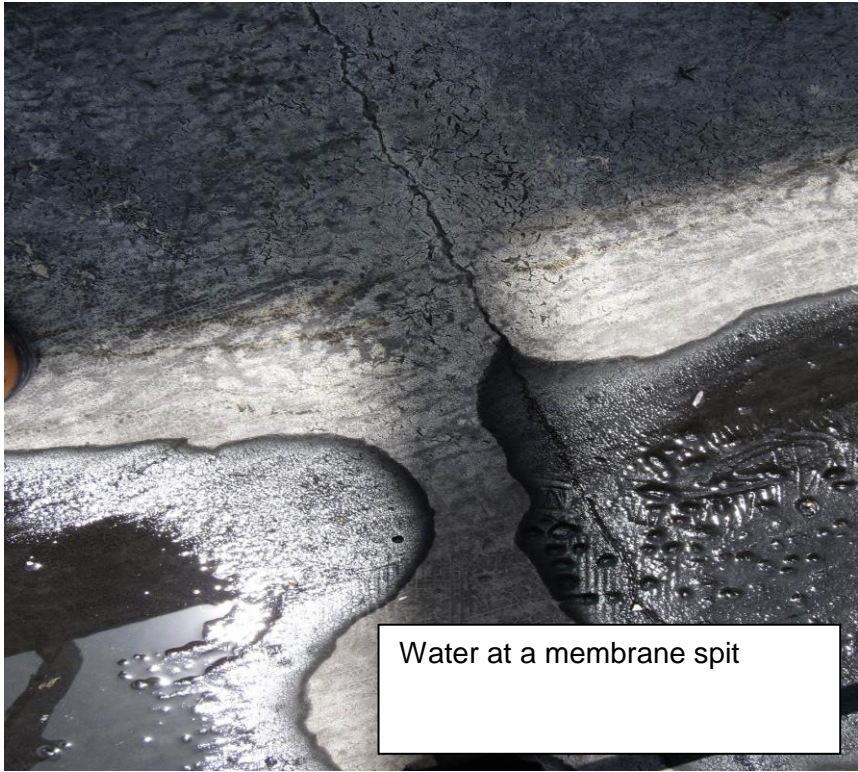
Water at a membrane spit

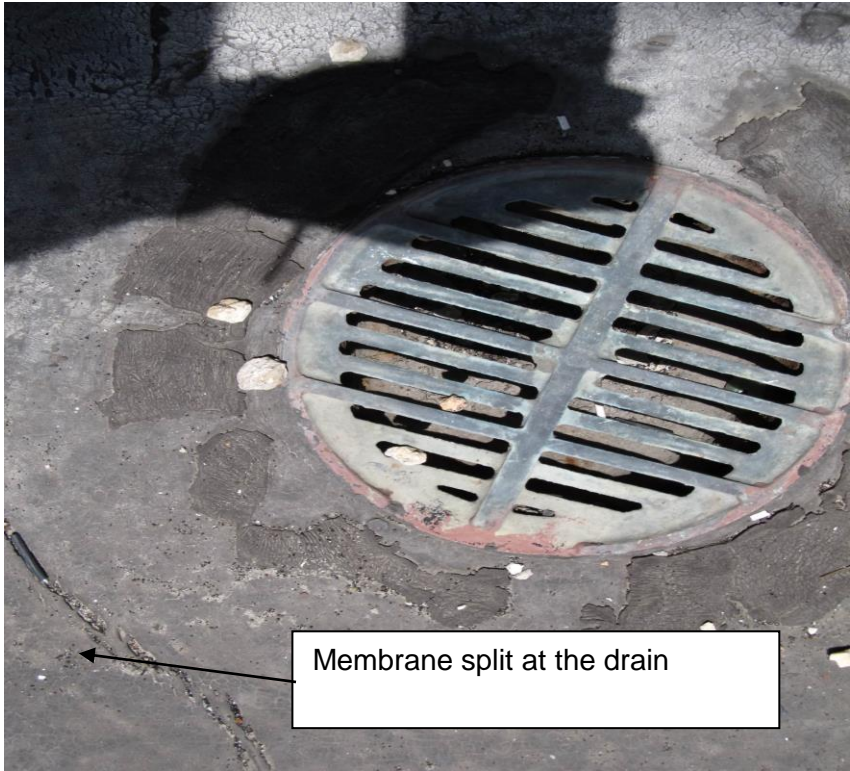
Membrane split at the drain

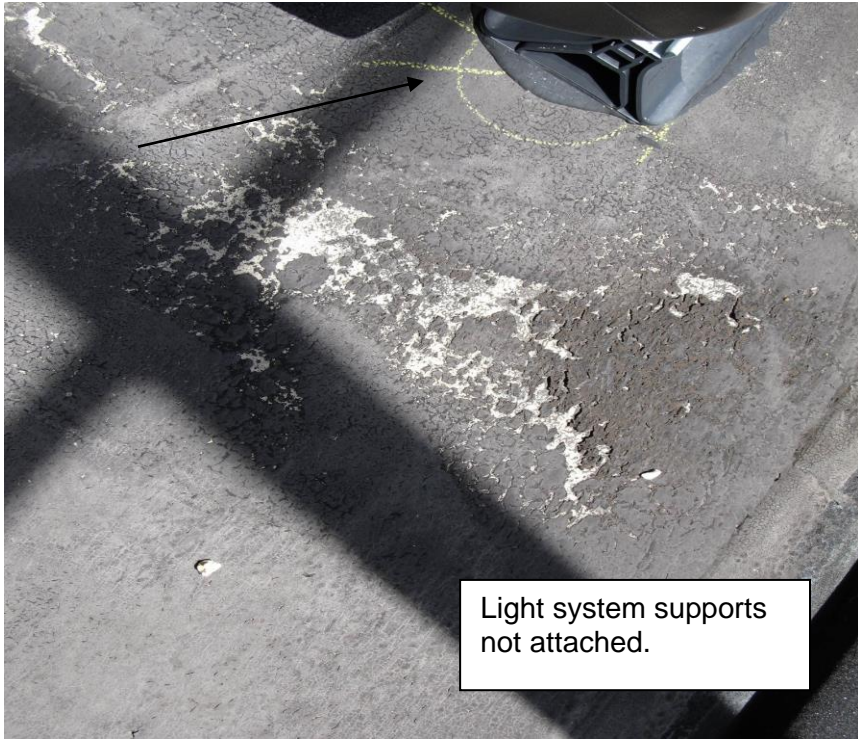
Light system supports not attached.

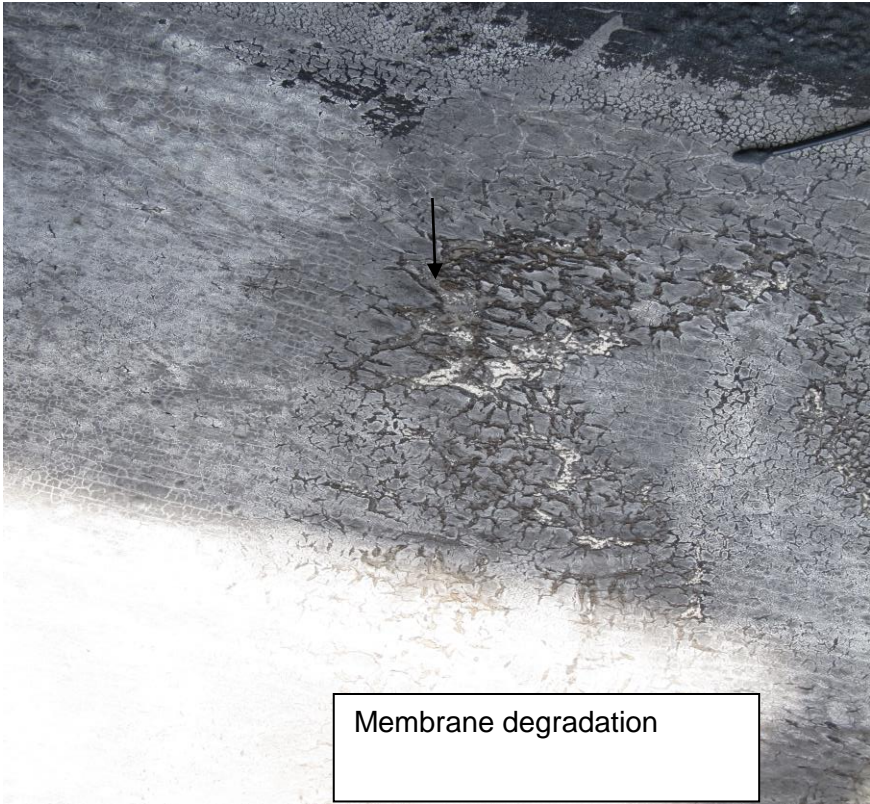
Membrane degradation

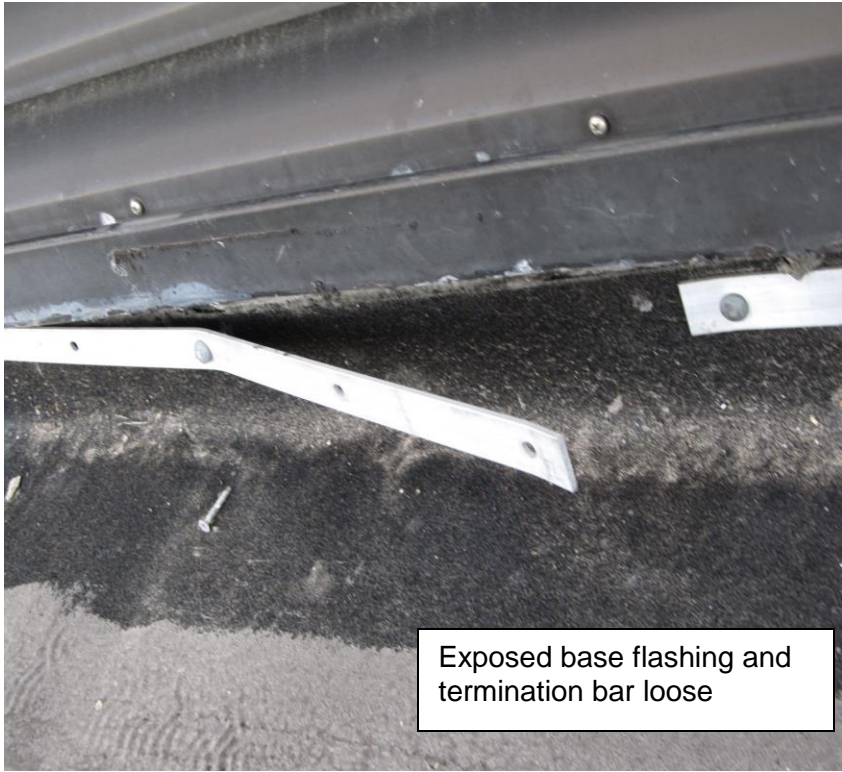
1.02.3 Flashing: The original flashing is intact, several areas of cracking and open flashings were noted in the inspection.

Exposed base flashing and termination bar loose

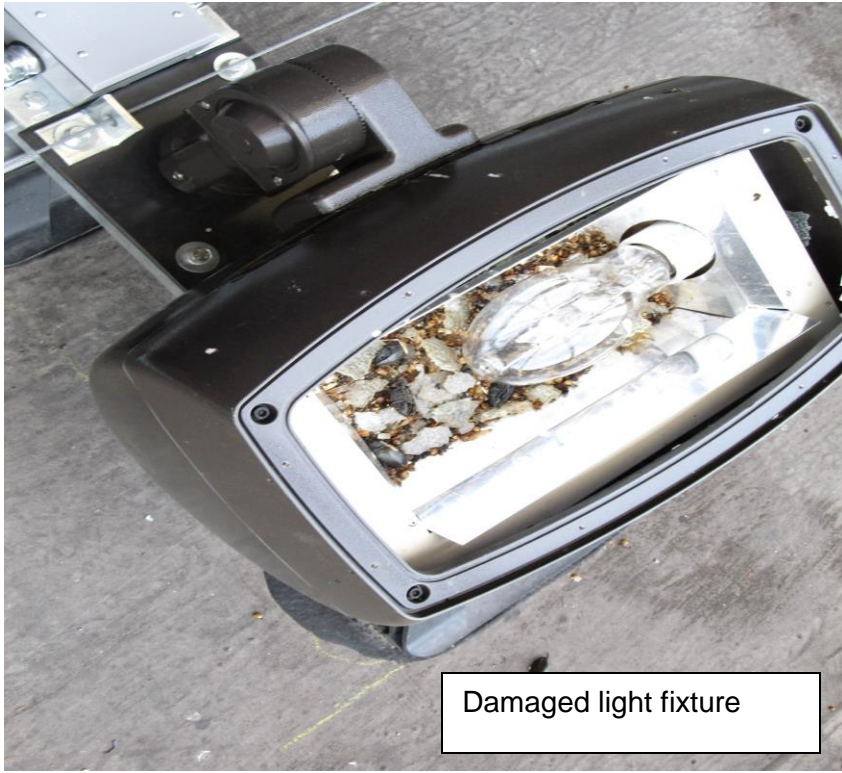
Damaged light fixture

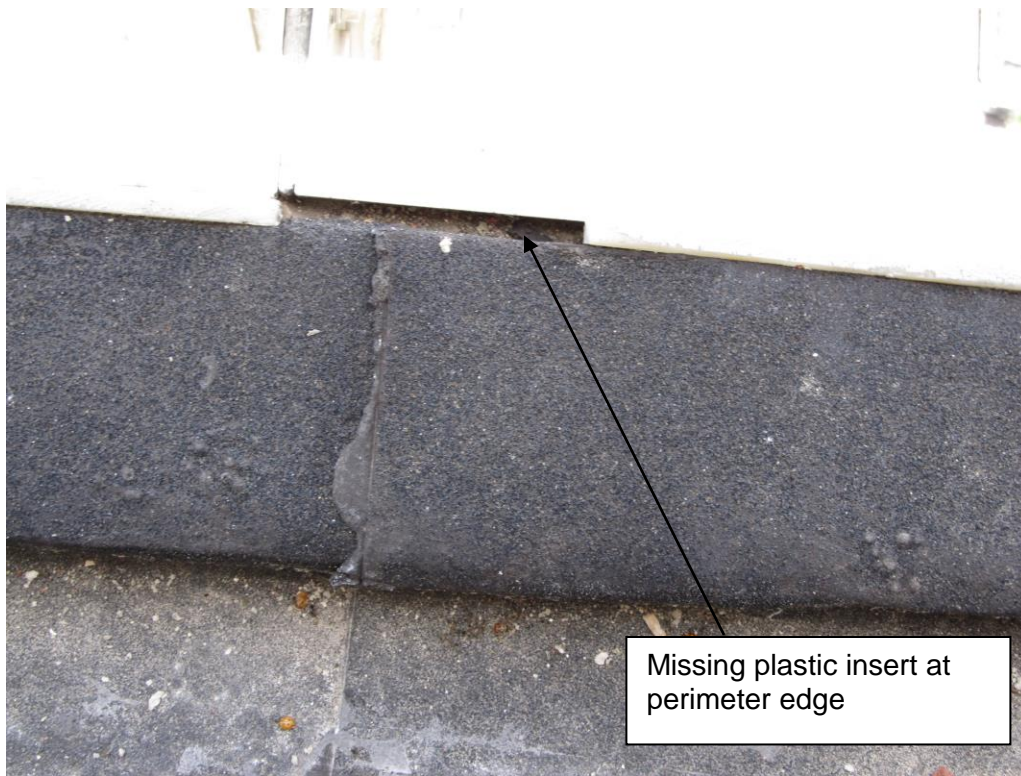
Missing plastic insert at
perimeter edge
